## memorandum

**Date:** May 5, 2022

**Re:** **Monterra HOA – Coastal Geologic Recommendations for unarmored coastal HOA**

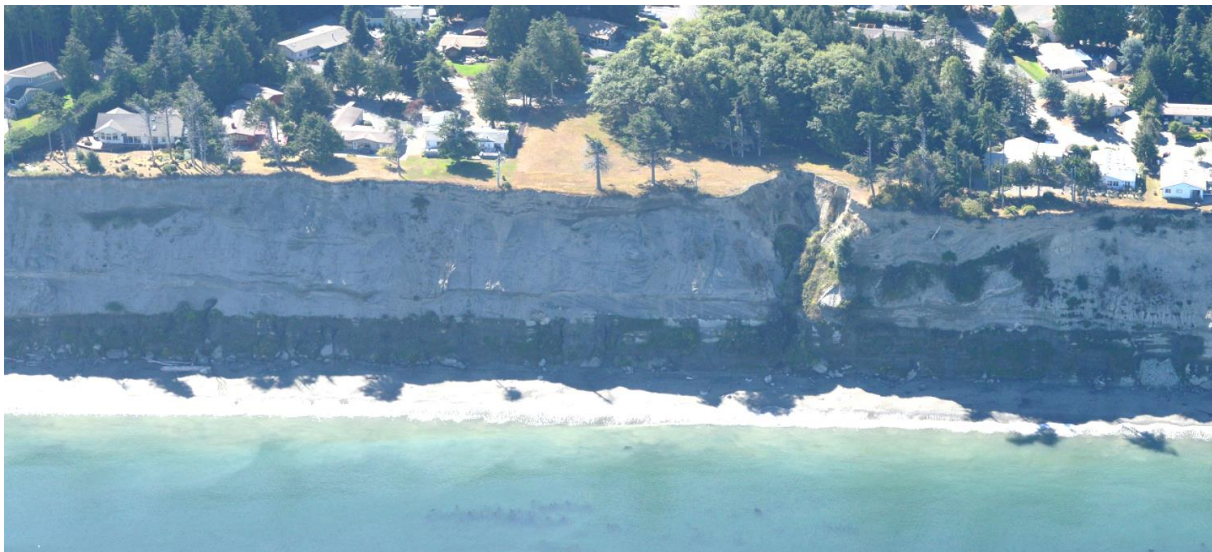
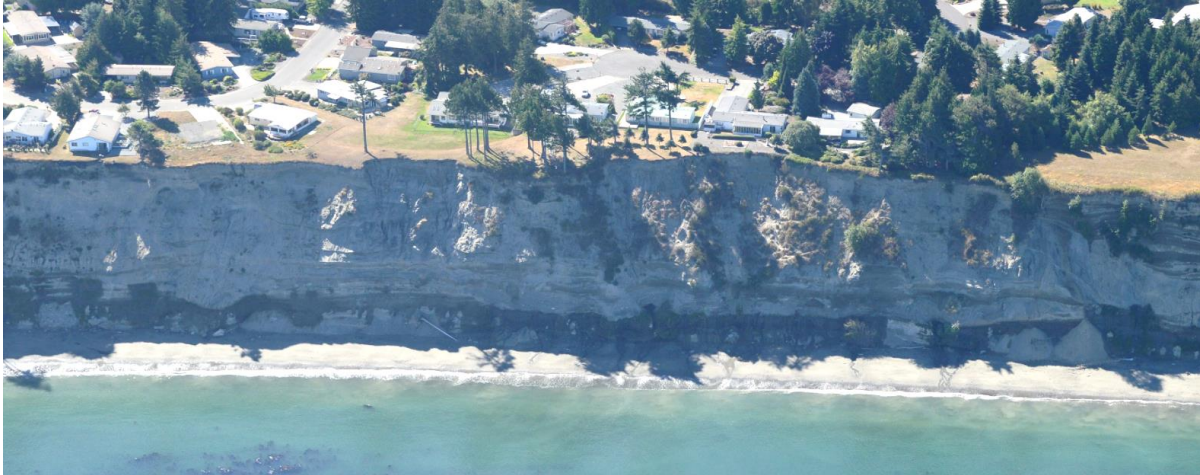
Figure 1a shows an oblique view of the HOA from a plane, illustrating the steep and mostly unvegetated nature of the bluff in this area.

**Figure 1a.** 2016 aerial oblique taken 8/12/2016. Upper photo shows west side of HOA and lower photo shows east side.

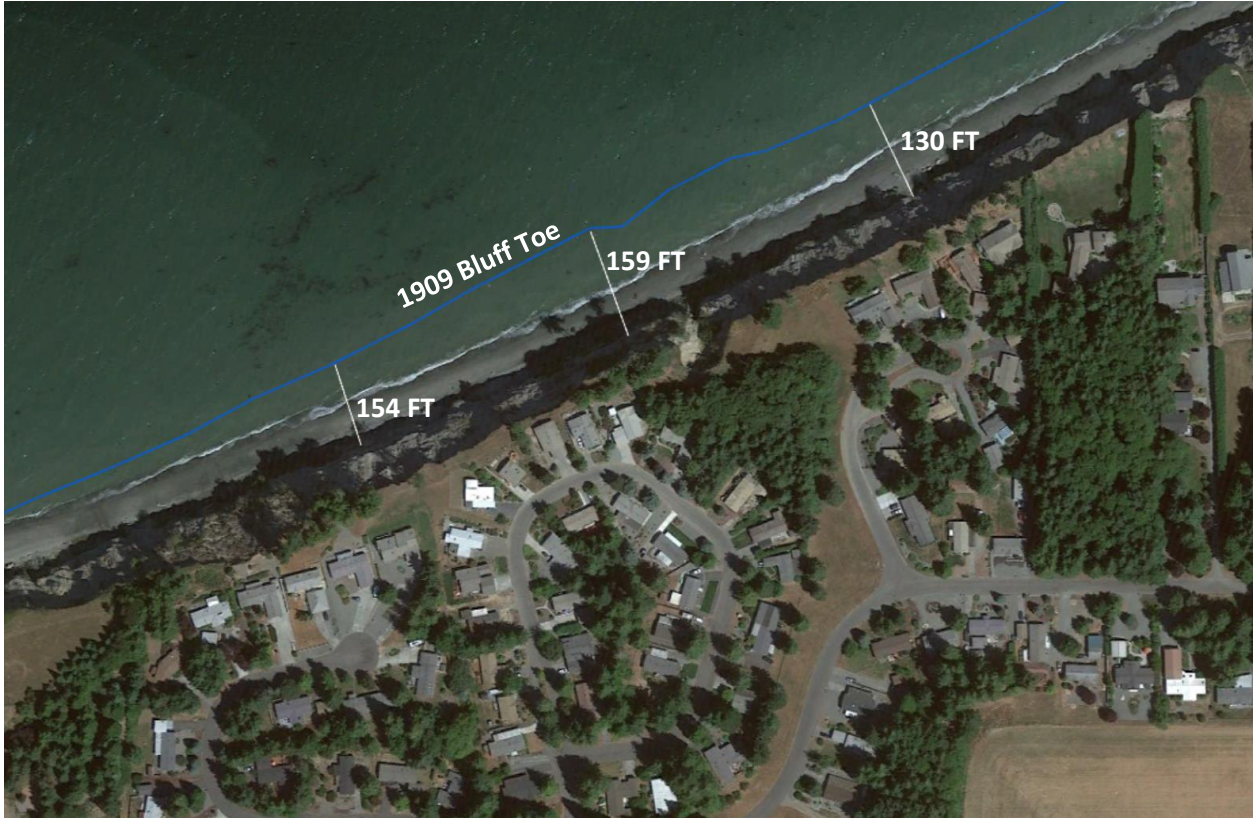
We also performed a simple analysis of bluff recession by comparing the 1909 Bluff Toe (as mapped in T-Sheets) to current aerial imagery (Figure 4). From this analysis we see between approximately 130 FT – 159 FT of lateral recession which equates to 0.8 FT/YR to 1.4 FT/YR between 1909-2021 along the HOA.

**Figure 4.** Distances from 1909 bluff toe as mapped in T-Sheets to 2021 GoogleEarth imagery.

Based on these data and best professional judgement, the estimated long-term bluff recession rate at the subject property now (which is thought to be faster than in the 20<sup>th</sup> century) likely on the order of 2 to 4 FT/YR. This annualized rate represents an average rate of change across a long period of time. In most cases in the region, erosion occurs episodically in change events that typically consist of a windstorm that coincides with a high-water event, prolonged rain, or rain on snow events. Large events that cause considerable bluff recession occur somewhat infrequently and are often followed by periods of lesser bluff activity. However, in this very active bluff reach, small surficial slides (sometimes called “sloughing”) and dry ravel occur somewhat frequently.

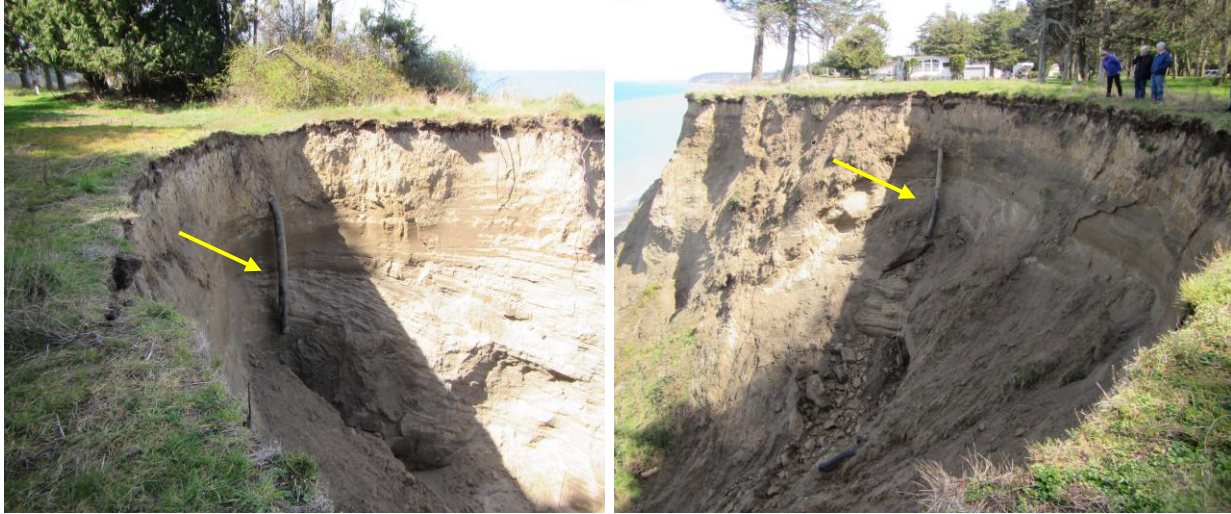
During the site visit I was informed that at approximately 162 Cypress Lane, drainage from the neighborhood is collected into a dry well. When the dry well overflows it is expelled towards the bluff in underground tightlines. I was informed that this usually happens during moderate to heavy rainfall events which include 0.5 inches of rain or more, or at least 10 times per year. Upon inspection, these overflow tightlines consist of two 10-inch corrugated plastic pipes which are broken, expelling water about 20 FT below the bluff crest in a ravine area (see Figure 6). Other remnant concrete drainage pipes were observed within the bluff face and broken at the base of the upper slope, which I was informed were thought to be inactive. Erosional channels below each of the tightlines were observed, indicating that water does flow into this area and actively erodes the bluff here.

**Figure 6.** Broken tightlines where overflow drainage expels in ravine northeast of Cypress Circle. Yellow arrow points to tightlines.

Our primary recommendation is to fix the two broken tightlines as shown in Figure 6, near 162 Cypress Lane. It appears that these broken pipes have led to significantly greater bluff recession in this ravine area and will continue to add to slope instability. While drainage collection can be one of the most efficient ways to reduce bank erosion where soils are very moist to wet and bank recession may directly threaten improvements, any pipe failure and discharge of collected water near a bank crest or on a bank face is much worse than having no drainage collection system at all in most cases. Note that good quality drainage material and installation is expensive to install properly and when installed using lower quality material (such as thin, single-wall pipe) or installation methods, can fail in a short amount of time. Drainage systems require monitoring if installed within the HOA.

If tightlines are replaced or added, avoid corrugated, single wall pipes, as they tend to fail after a limited number of years. The only material suitable for safe installation of a drainage system and use on high and/or unstable bluffs is high-density polyethylene (HDPE). This material is very high strength but needs to be heat welded on site from 40 or 20 FT long pieces. Welding is best completed by a certified welder for this type of material. An HDPE installation is considerably more expensive but will greatly outlast cheap, single-wall pipes by an order of magnitude. Tightline pipes should be routed to the base of the bluff and have an energy diffuser Tee at the bottom. Note that permits are required from WDFW for drainage that is routed to the beach.

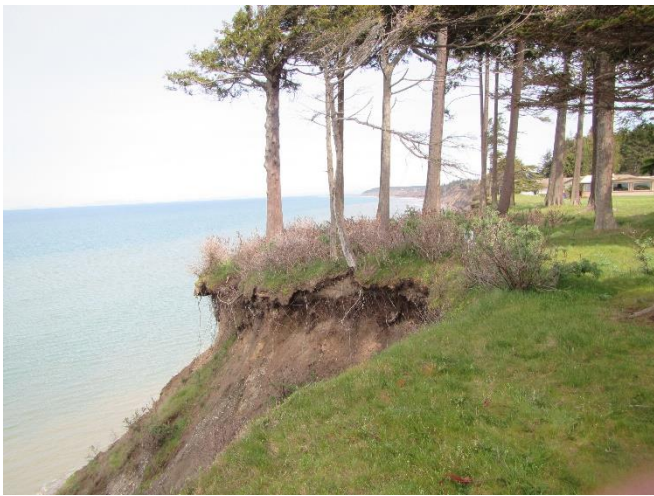
The vast majority of the bluff was unvegetated besides some grasses and other sparse immature weeds and dunegrass. The bluff crest of the HOA was largely lawn, with some cedars, salal, ocean spray, English ivy and other grasses (see Photo Pages). Several firs and cedar trees were located within 5 FT of the bluff crest and showed signs of undercutting.

**Photo 3.** Bluff crest with trees slowing some undercutting.

Preserve all trees currently present on the property. Tree roots enhance bluff integrity and provide moisture control. Some trimming is permissible to maintain view corridors. If a tree is in close proximity to the bluff crest and is becoming undermined or you observe other issues with the tree, hire a certified arborist to evaluate the tree. In some cases, if a tree is determined to be imminently at risk of failure, cutting the tree down before it falls is better for slope stability as you can retain the roots for several more years without the possibility of the whole tree and root wad getting ripped out.

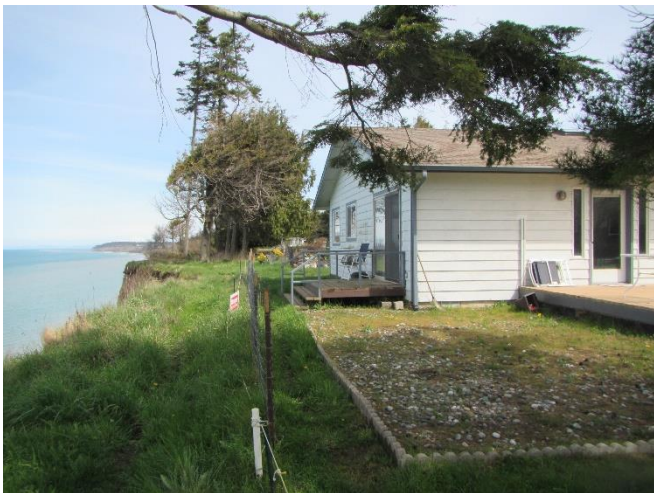
**Table 1.** House, deck, and septic setbacks and locations for several homes within the HOA. Note 192 Cypress Circle has the smallest setback in the HOA.

**Photo 5.** Small setback from bluff crest at 192 Cypress Cir.

Based on the setback measurement made during the site visits and historic bluff recession rates, the home at 192 Cypress Circle should consider moving their house immediately to continue safe use of this home. Other homes with setbacks less than 35-40 FT to the house, should start to consider options for structure relocation. As these homes are single story without basements this action is likely feasible. Homes where septic systems (drainfields, tanks) are waterward of houses and within 30 FT of the bluff crest should also consider moving their systems landward or adjacent to their house. Homes and infrastructure can only be moved while the bluff crest is stable enough to support the equipment required to do so.

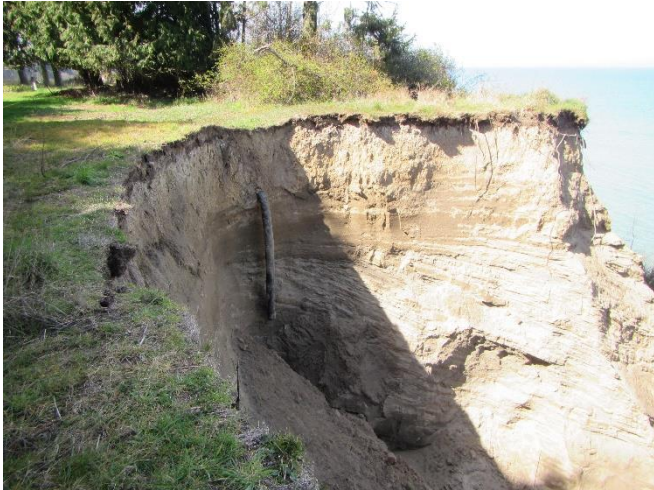
**Photo 7.** Ravine with broken drainage pipe, looking west.

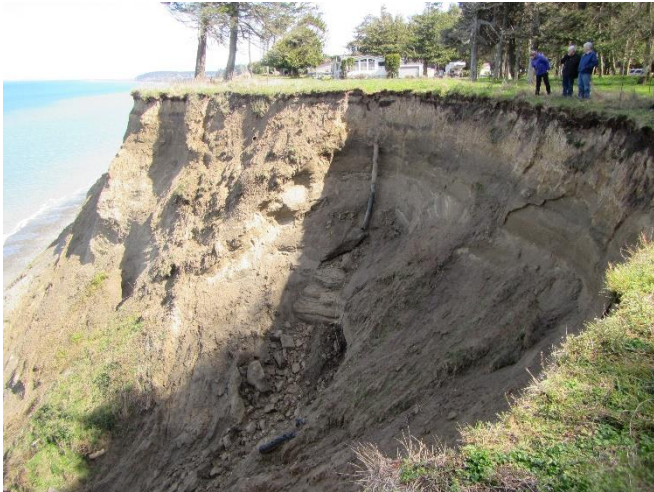
**Photo 9.** Ravine with broken pipe, looking east.

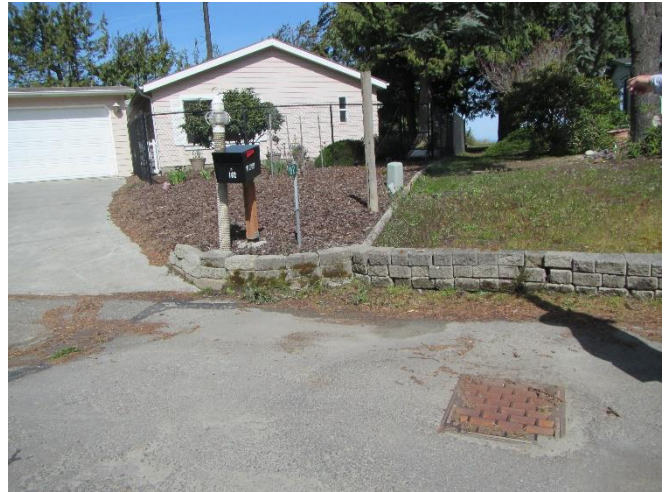
**Photo 10.** Drainage culvert at 162 Cypress Cir, looking towards bluff.

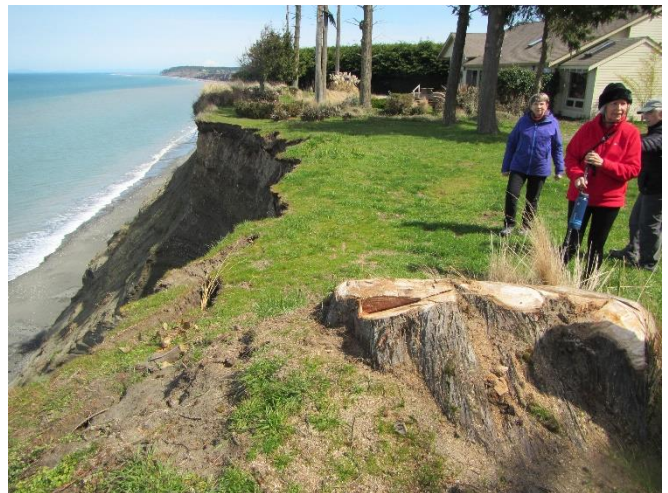
**Photo 12.** Trees cut at 112 Sea Bluff Lane, and visible cracks along bluff crest.
